TECHNICAL REPORT ARCCB-TR-03009

THERMOMECHANICAL AND FRACTURE ANALYSIS OF SILICON CARBIDE IN CANNON BORE APPLICATIONS

J. H. UNDERWOOD P. J. COTE G. N. VIGILANTE

JUNE 2003

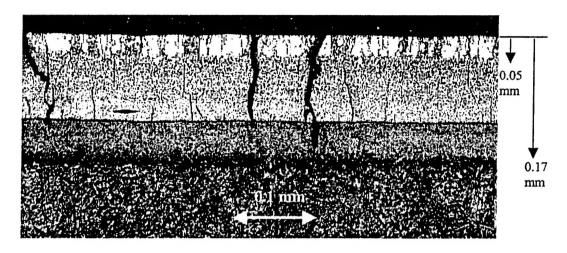
Figure 1 is a metallographic cross section of a chromium plated A723 steel sample that has been laser heated to simulate cannon firing. Twenty 5-ms laser pulses (ref 3) were applied with about 1 J/mm² heat input during each pulse, which corresponds to 200 W/mm² heat flux, typical for tank cannon firing. Note that this is considerably higher than the 1 W/mm² heat flux for typical gas turbine applications (ref 4). The key features of laser thermal damage are similar to those observed from firing damage (refs 1,2). They are, from top to bottom in Figure 1:

- The 1320°K recrystallization and grain growth of chromium, to a 0.05-mm depth in the case here
- Cracks through the chromium and continuing into the steel
- The 1020°K steel transformation, to a depth 0.17-mm below the surface.

Figure 1. Near-surface thermal damage in laser-heated chromium plated steel sample #L1.

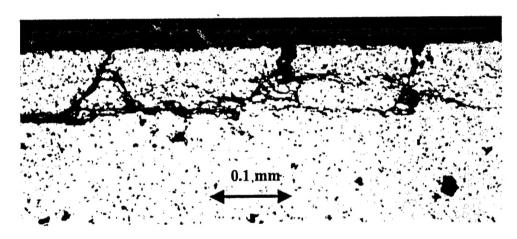
Figure 2 is a metallographic cross section of Hexoloy SA SiC that has been laser heated to simulate cannon firing, using ten 5-ms laser pulses at about the same heat input level as that for the chromium-steel sample in Figure 1. There were no obvious transformations as in the chromium-steel sample, but cracking in two orientations can be seen, normal and parallel to the heated surface (at the top of the photo), to a depth of 0.08-mm. The similarity in cracking damage for the chromium-steel and SiC samples was the impetus of the effort here to apply the thermal damage model used for cannon coatings to describe the observed laser thermal damage in SiC.

Figure 2. Near-surface thermal damage in laser-heated SiC sample.

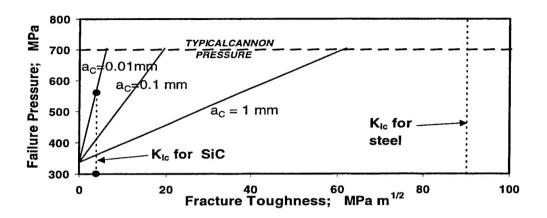
Equation (3) was evaluated for typical cannon values of w = 2 and $S_B = -900$ MPa to produce the failure predictions shown in Figure 5, that compare the failure behavior of a ceramic-bore tube with that of a steel-bore tube. Note that for a lower-bound K_{Ic} for steel of 90 MPa m^{1/2} and $a_c = 1$ -mm, the failure pressure is safely above the cannon firing pressure of 700 MPa. In contrast, for a typical K_{Ic} for SiC of 4 MPa m^{1/2} (ref 6) and $a_c = 0.01$ -mm, the failure pressure is below the cannon firing pressure. Recall that the observed crack depth in the laser-heated SiC sample shown in Figure 2 was 0.08-mm, well above the 0.01-mm a_c . This indicates that the use of the SiC considered here will result in extensive cracking, initiated by thermal damage and propagated by the cannon firing pressure.

Figure 5. Fracture analysis of pressurized cannon with varying a_c and K_{Ic} .
